CASE STUDY

Odour Investigation, Indoor Air Quality Assessment, and UST Removal

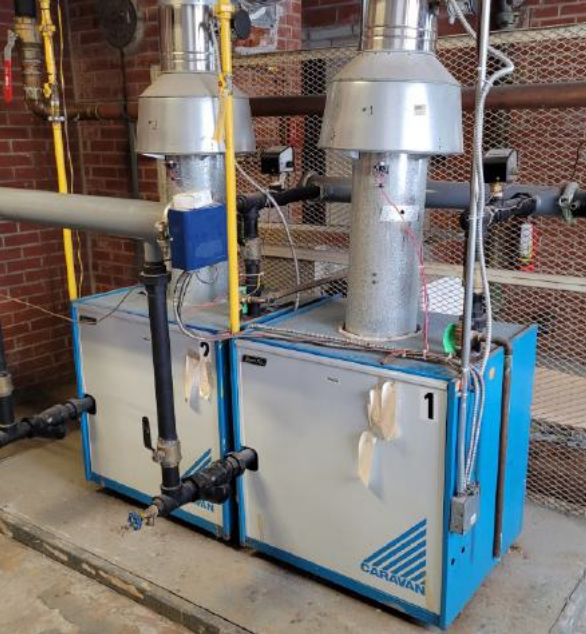
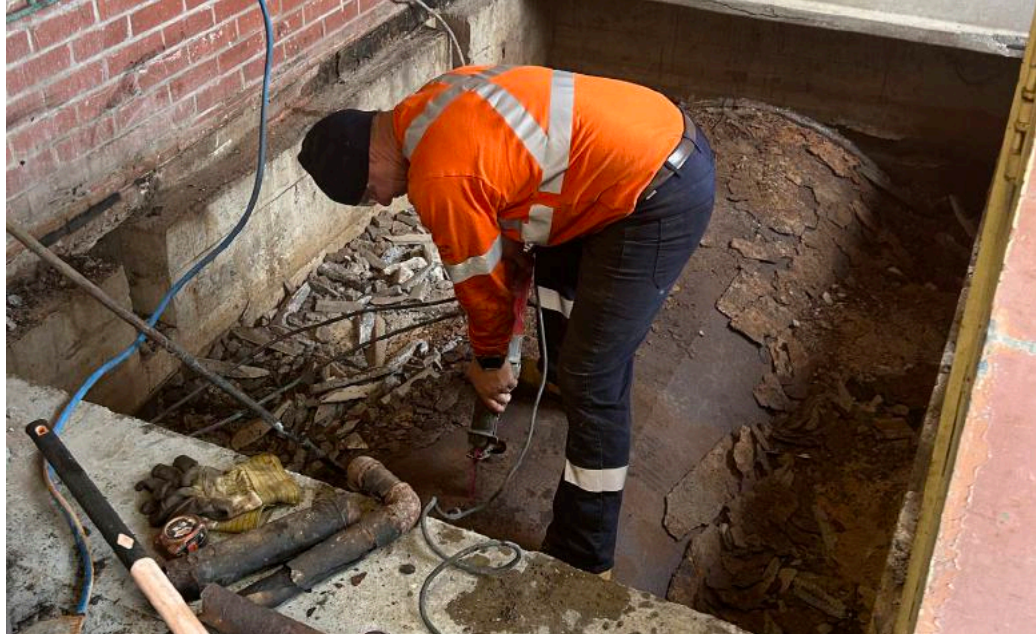
Given the nature of the odour and VOC profiles, CM3 recommended further investigation. This led to the identification of a previously undocumented steel underground storage tank (UST), located in a vault below the custodial supply room near the building's boiler room. Approximately 3,700 litres of diesel fuel were recovered from the tank, which was found to be heavily corroded with multiple perforations.

Working in coordination with a sub-contracted petroleum remediation contractor, CM3 supervised the full removal of the UST. Key activities included:

- Removal of the concrete vault and contaminated soil (10.9 tonnes)
- Collection and laboratory analysis of soil samples for BTEX and PHCs (F1-F4)
- Installation of a passive vapour mitigation system to prevent future odour migration
- Restoration of the flooring system
- Soil samples were tested, and all results were below applicable MECP Table 3 Site Condition Standards, indicating no further environmental concerns post-removal.
